Memo

To: Bob Schaefer, P.E., Asst. Dir. of P.W.

Re: Closed Burger Station Inspections 3/25-26/1998 you requested.

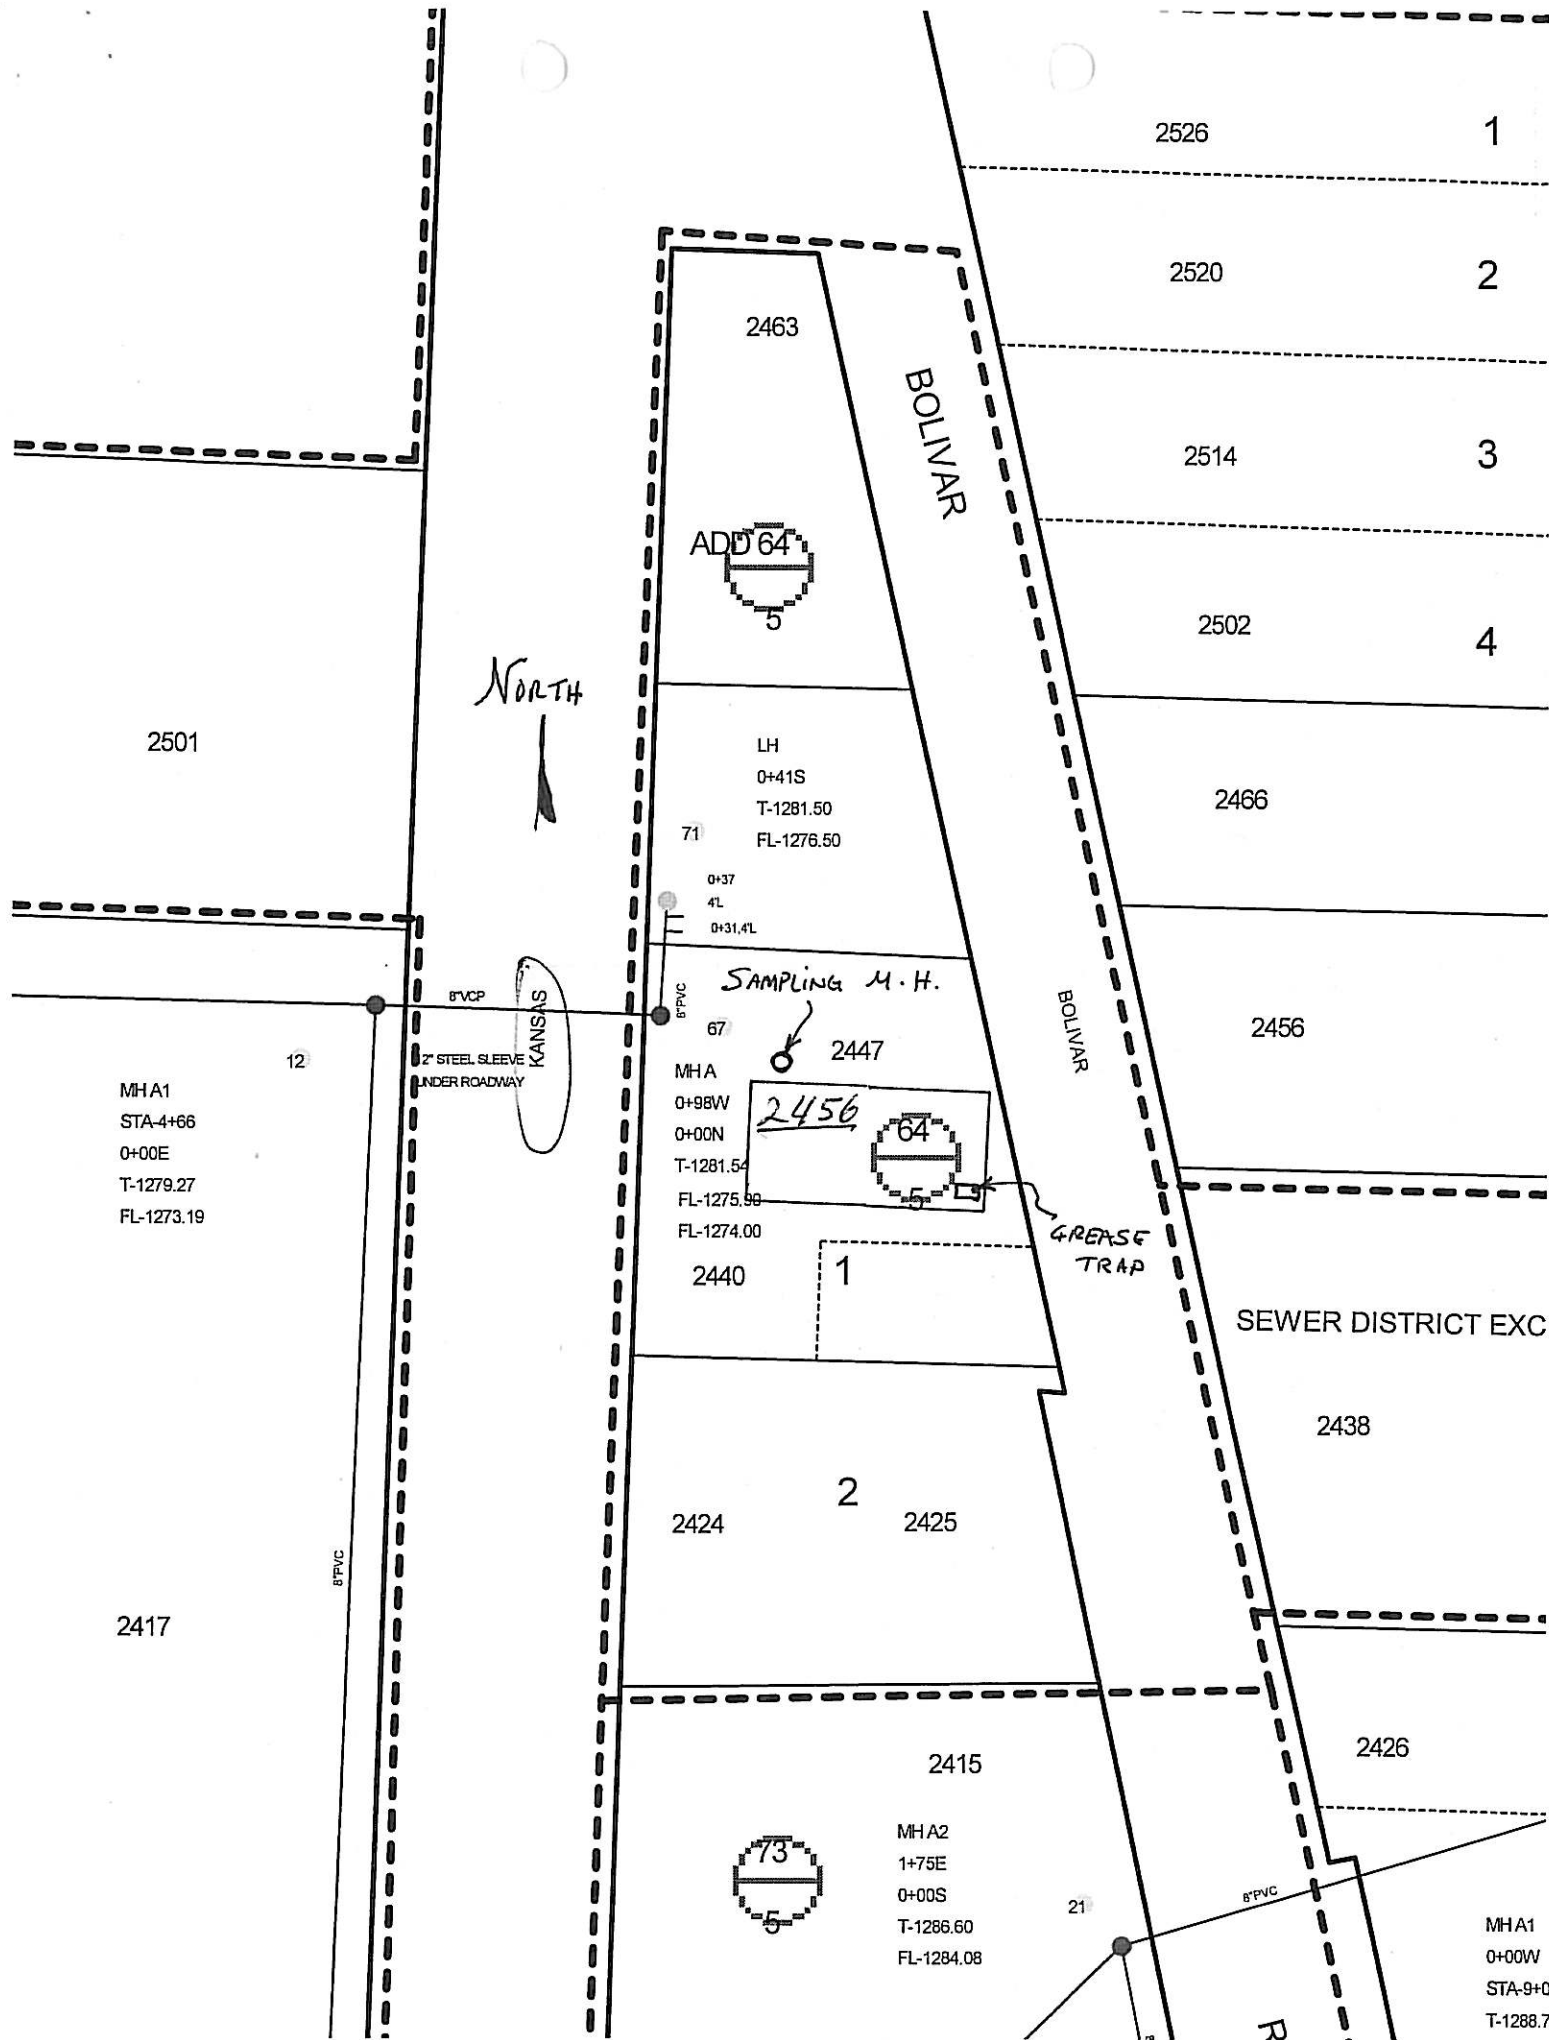
2456 N. Kansas Expressway

Closed. Sampling manhole present, holes near bottom with rocks and dirt protruding in, not concreted in, no apparent seal between wall and floor, invert shelves full of dirt, no ram-nek visible under ring and lid casting. Pipe has been sawed out to allow sampling. No grease noticeable in sampling manhole. No outside grease trap. Building was locked and all fixtures removed. By looking through the window it appears to have a 20(?) pound grease trap in the floor where the 3-vat sink used to be. Had a Crouch casting.

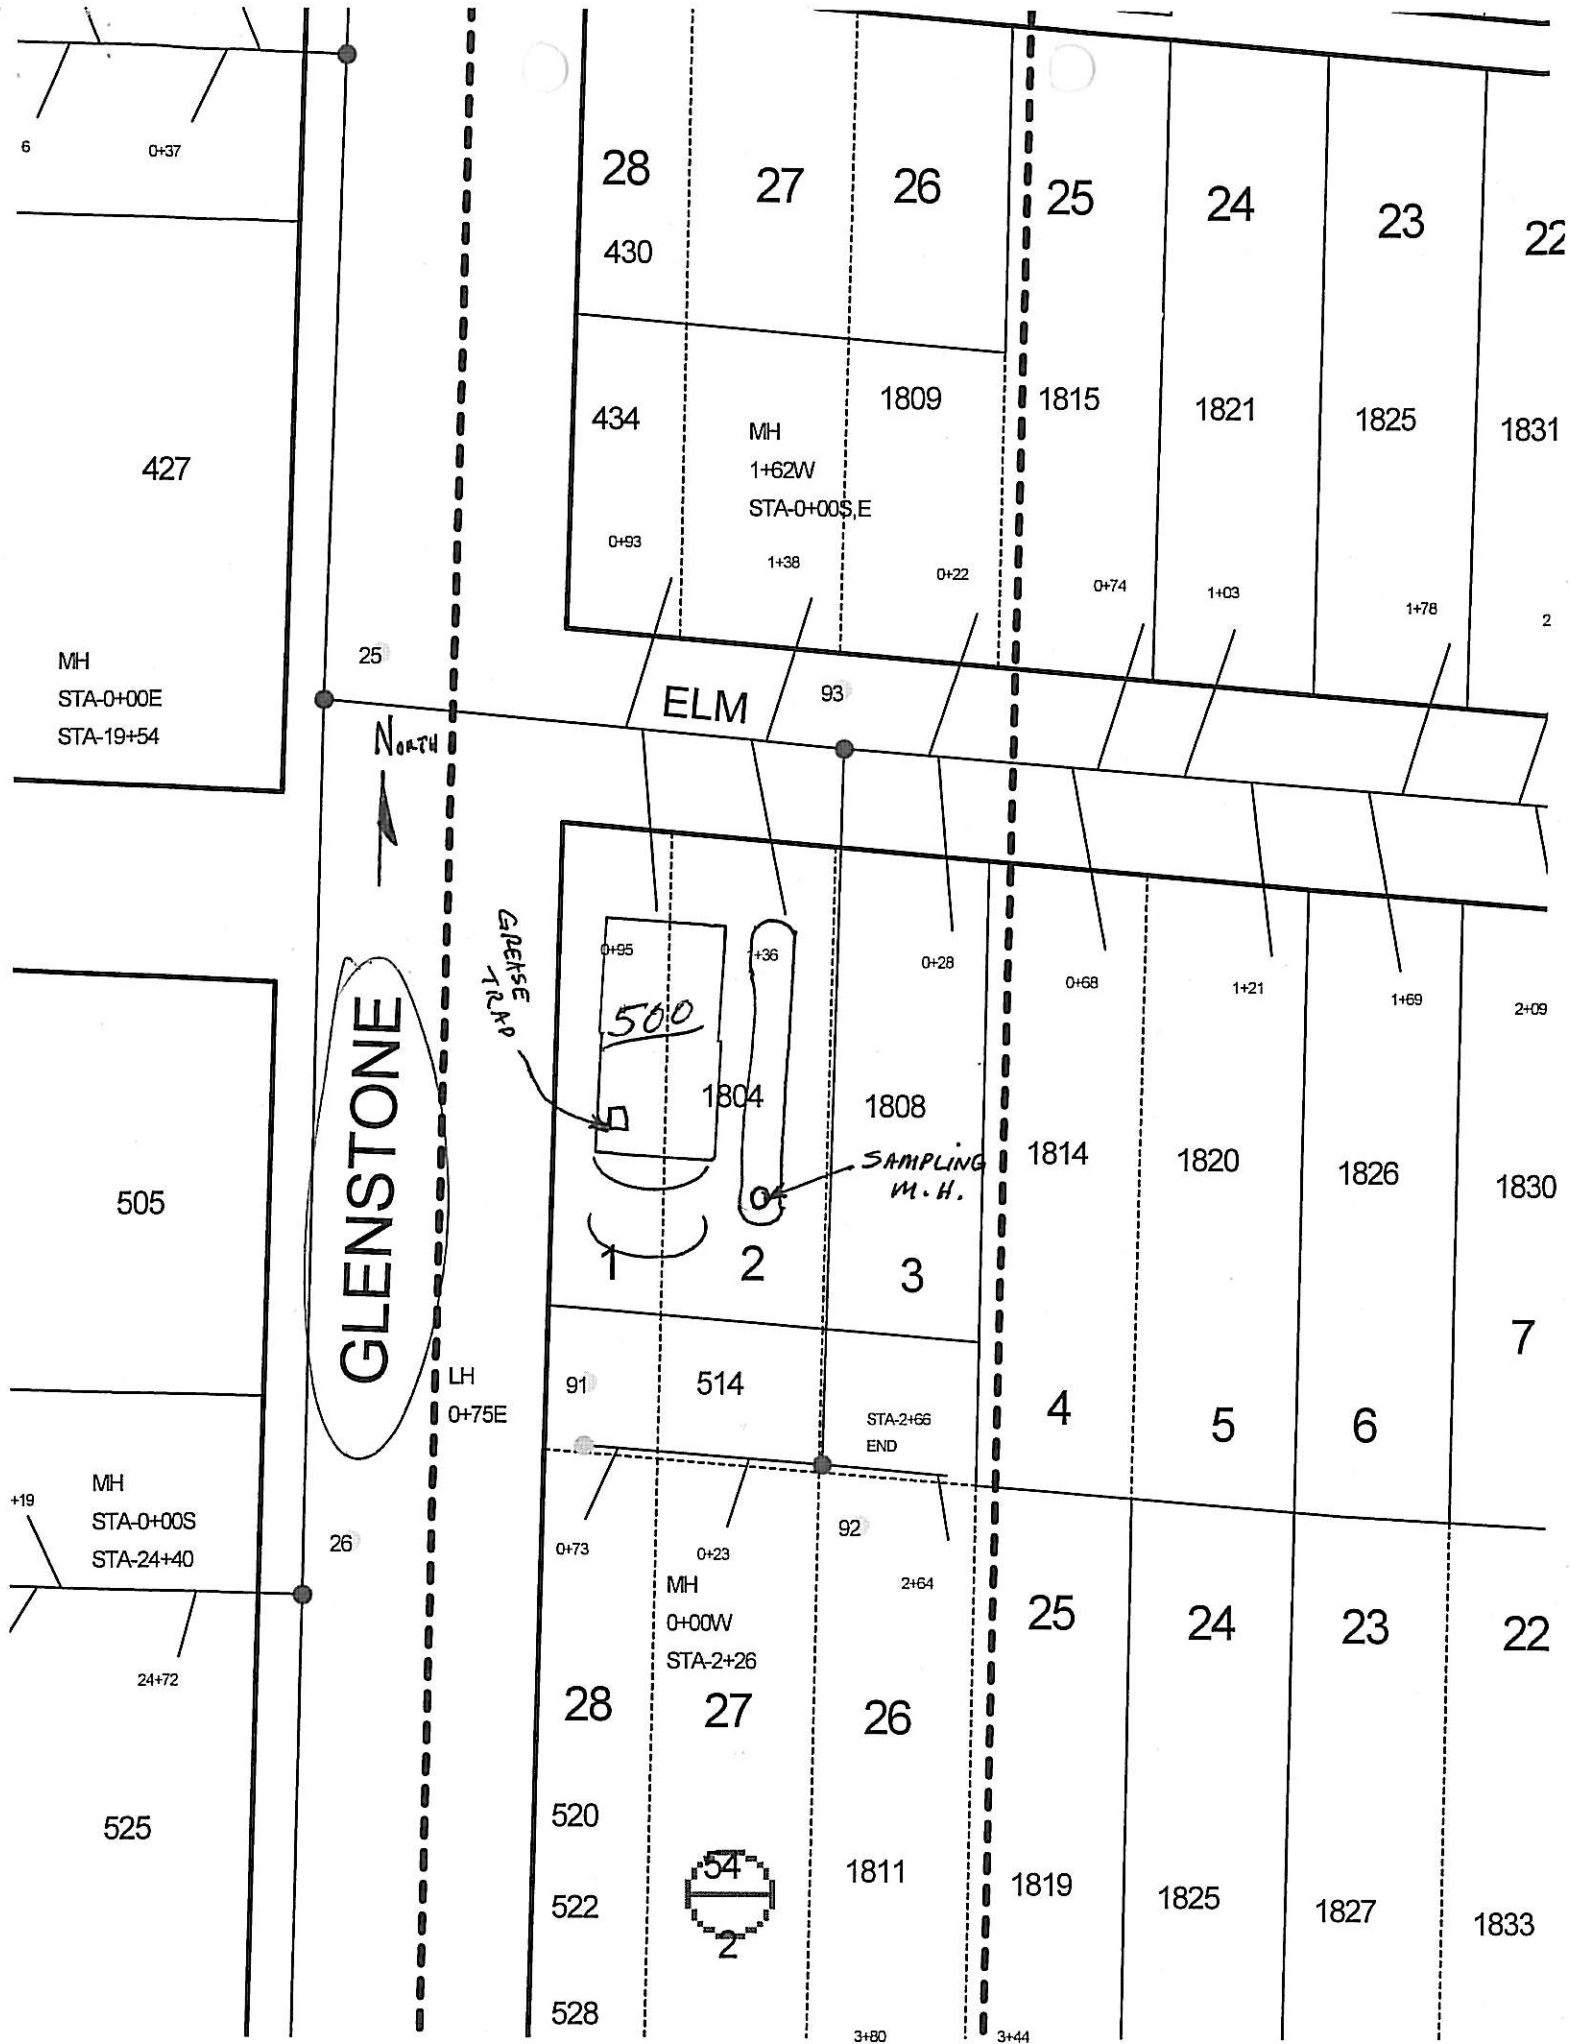
500 S. Glenstone

Closed. Sampling manhole present, holes near bottom with rocks and dirt protruding in, not concreted in, no apparent seal between wall and floor, invert shelves full of dirt, no ram-nek visible under ring and lid casting. Pipe has been sawed out to allow sampling. No grease noticeable in sampling manhole. No outside grease trap. Building was locked and all fixtures removed. By looking through the window it appears to have a 20(?) pound grease trap above the floor where the 3-vat sink used to be. Had a Neenah type locking lid casting.
